CESSNOCK LGA
PEDESTRIAN ACCESS AND MOBILITY PLAN (PAMP)

Project No: P2284 Version No: 006 Issue date: 5th August 2016

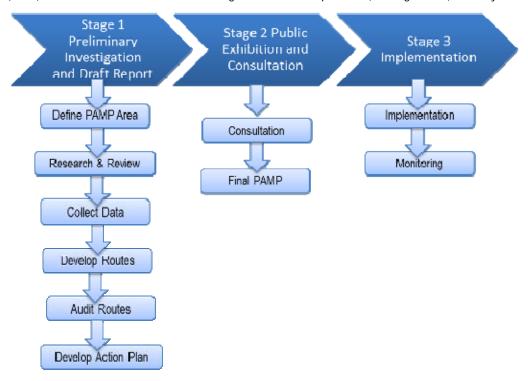
Figure 1.1: PAMP Development Methodology

The purpose of this PAMP is to guide the future provision and management of pedestrian access and mobility facilities within Cessnock. To achieve this, this PAMP has been produced in accordance with 'How to Prepare a Pedestrian Access and Mobility Plan (2002)' by the NSW Roads and Maritime Services (RMS). This document identifies three stages in the PAMP process (see Figure 1.1), namely:

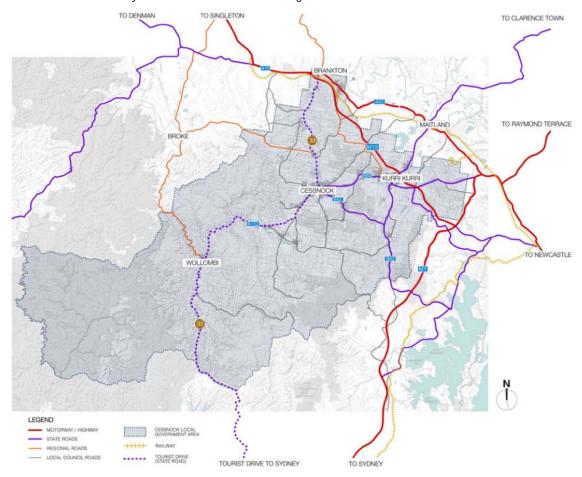
Figure 2.8: Existing Road Hierarchy

A network of state roads is present within Cessnock LGA which connect Central Cessnock to Kurri Kurri, Maitland, Newcastle and other regions of the coast. State roads are fully funded by RMS. The existing functional road hierarchy within the LGA is shown in Figure 2.8 and described in more detail in Table 2.1.

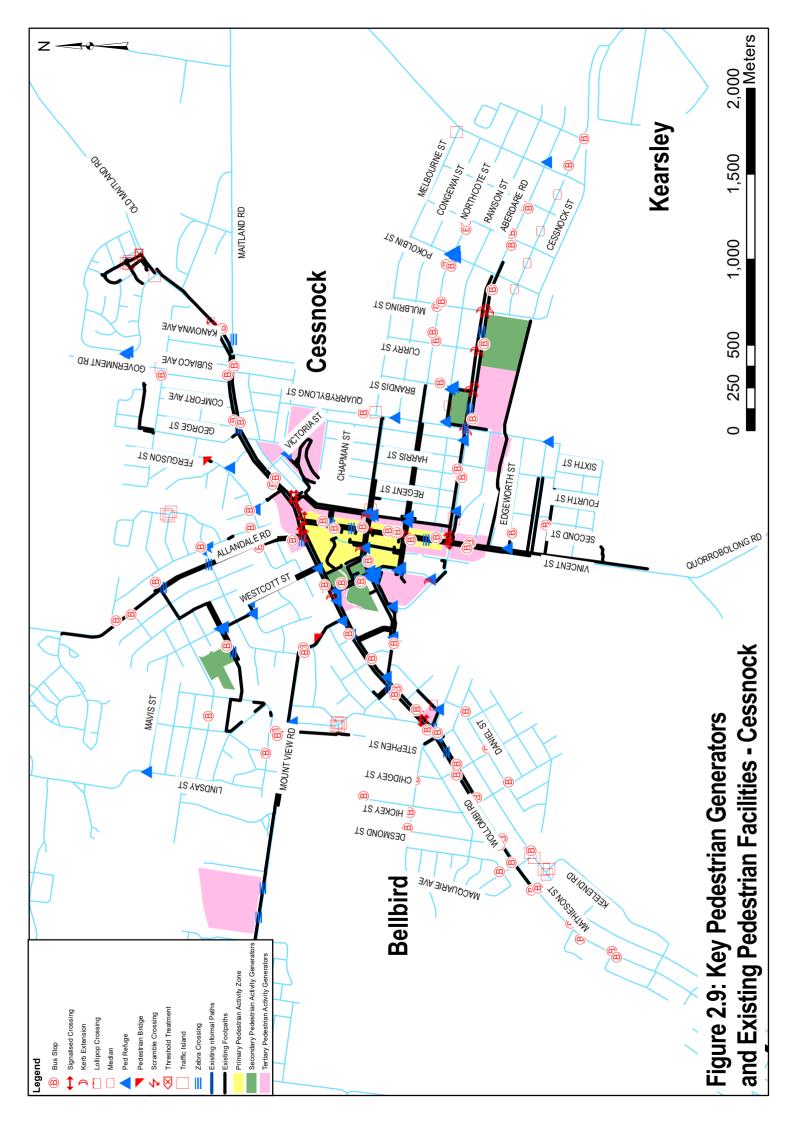
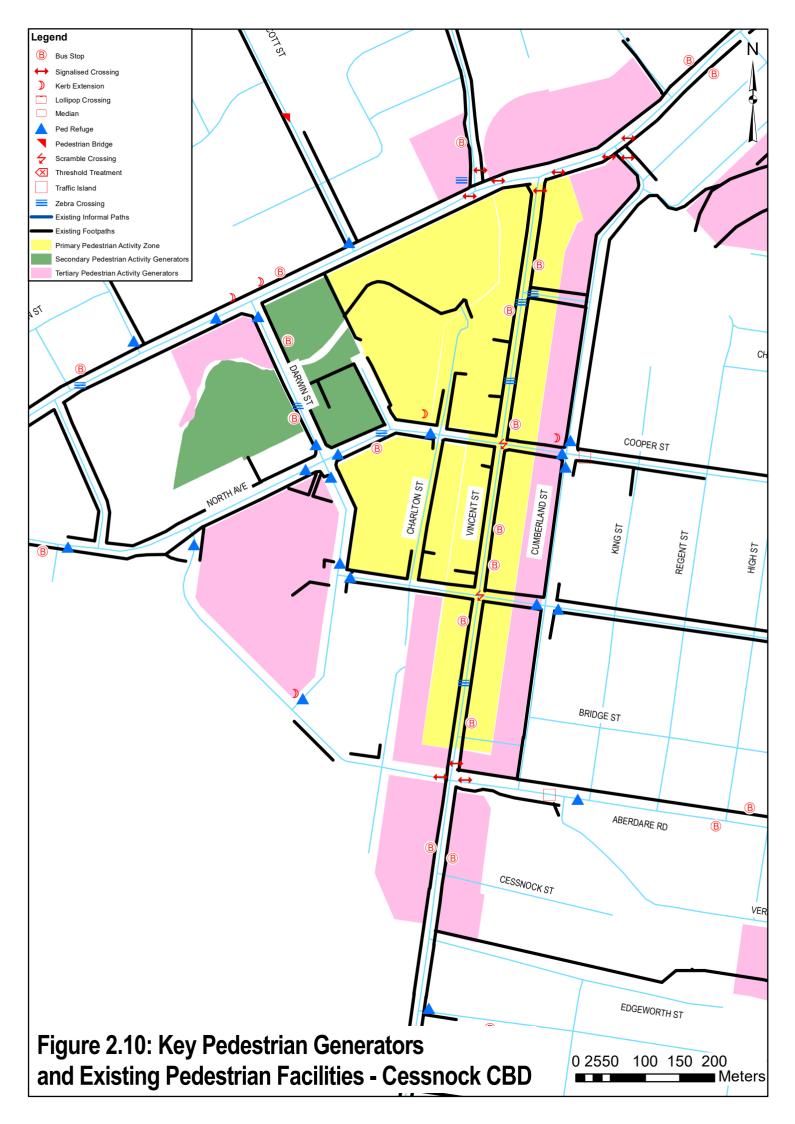
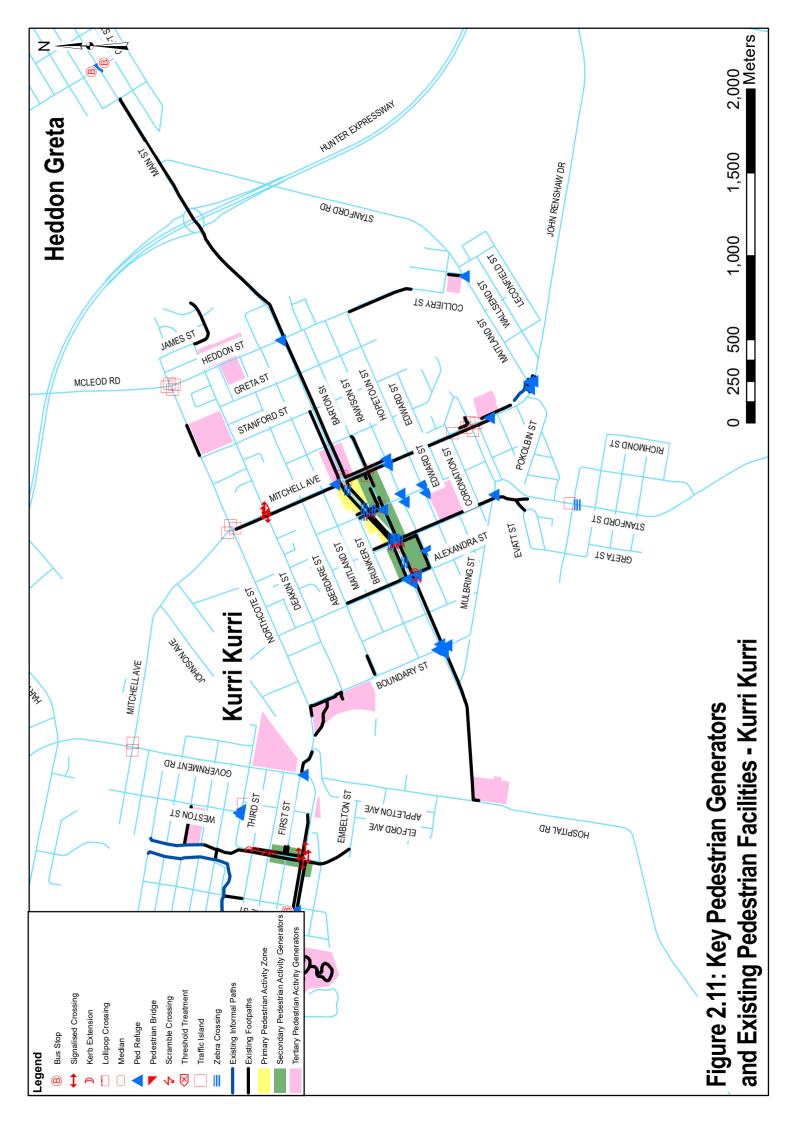
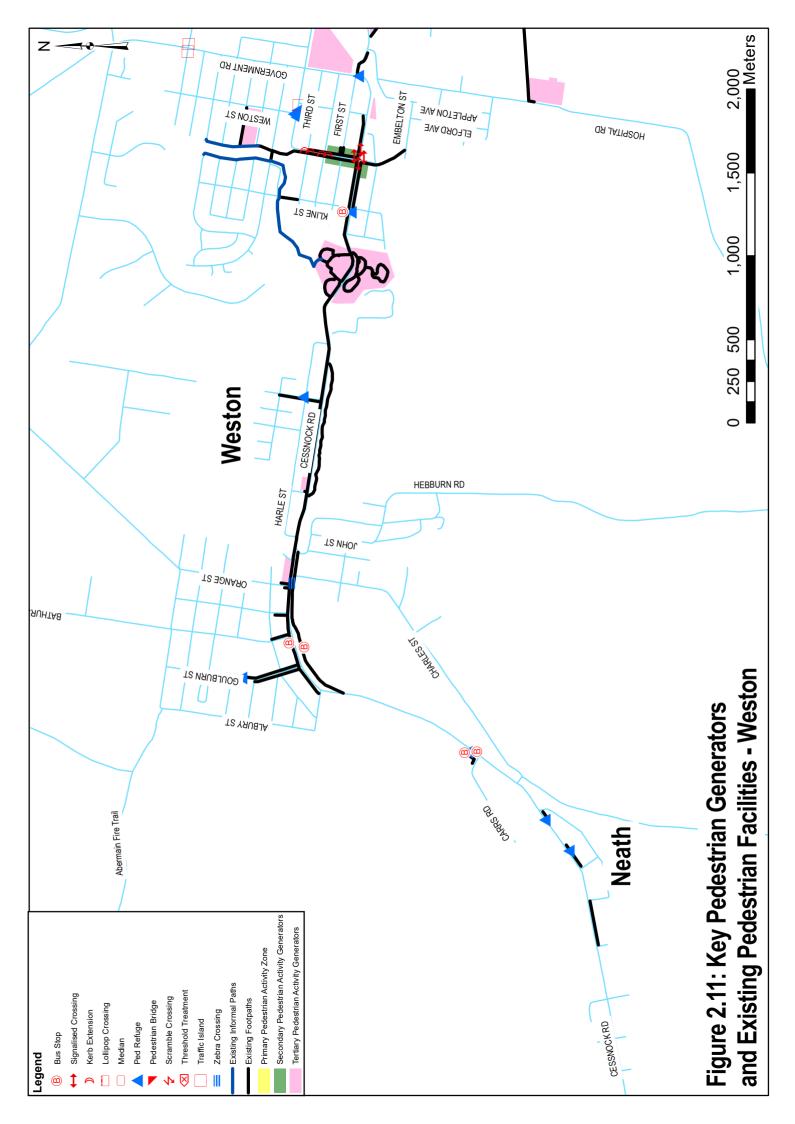
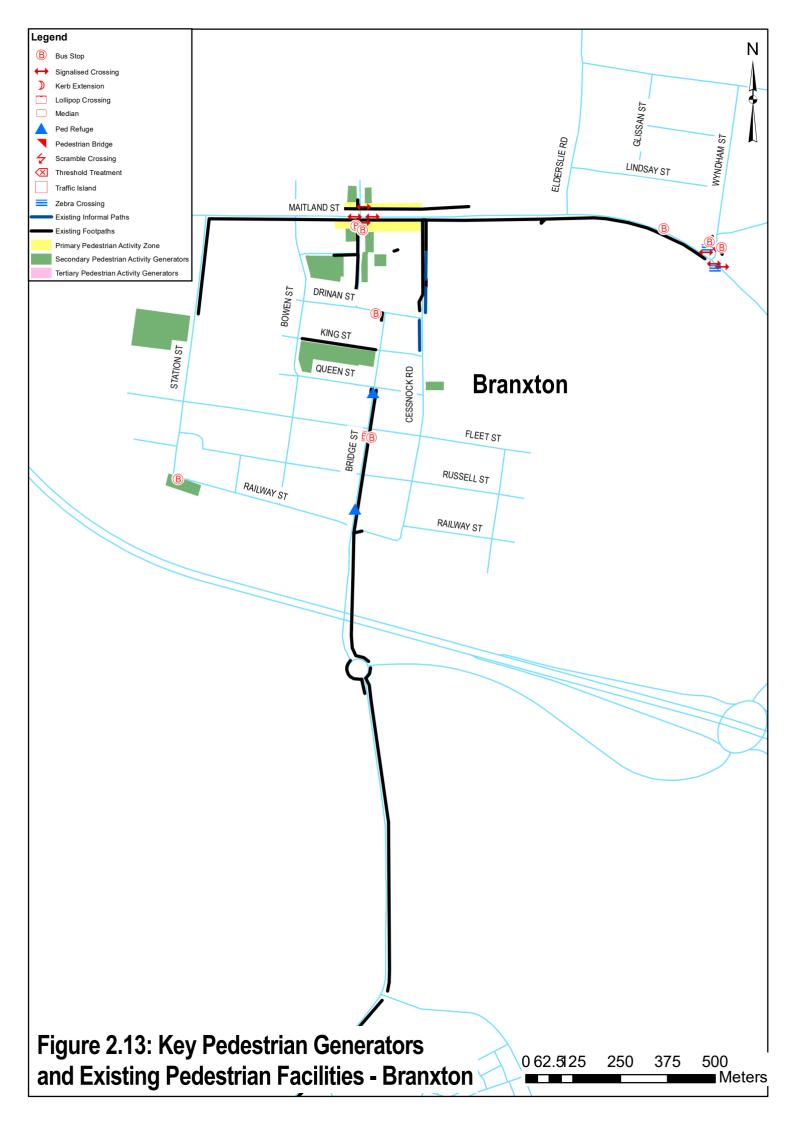
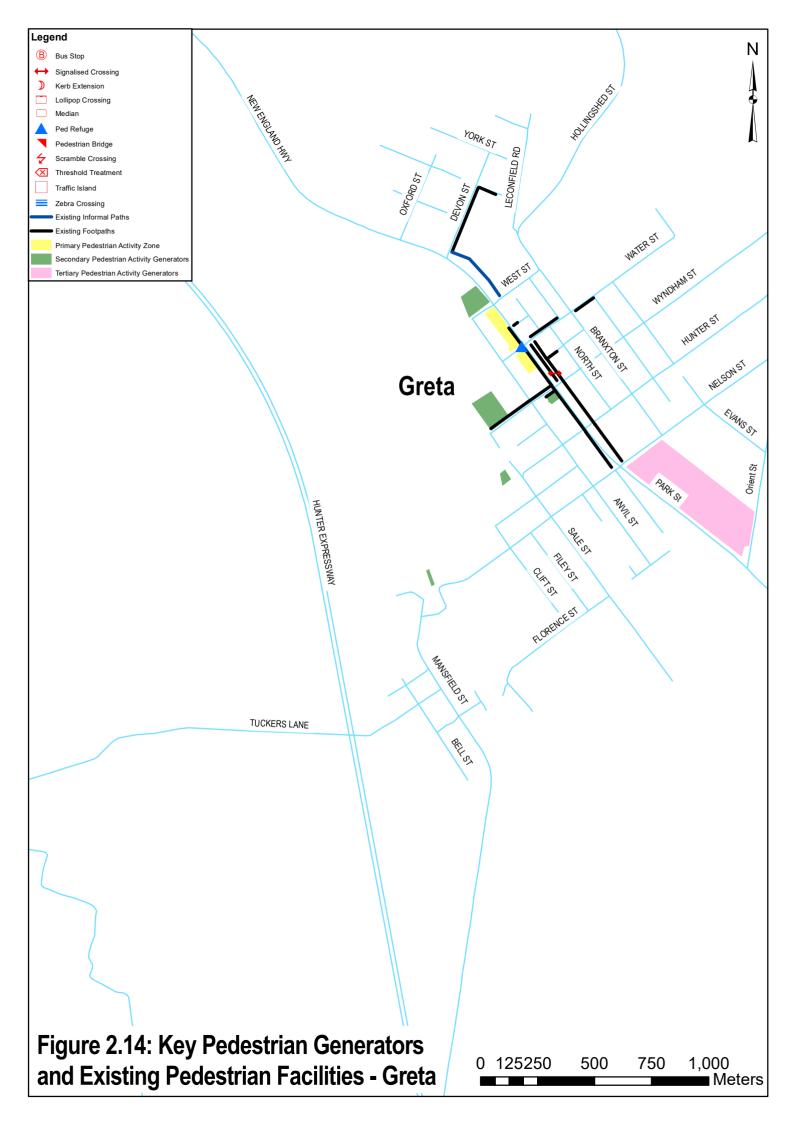
These were qualitatively ranked into Primary, Secondary and Tertiary areas/pedestrian generators based on the size and concentration of these land uses. Figures 2.9 – 2-14 illustrates the key pedestrian generators within Cessnock LGA, as well as the existing pedestrian facilities.

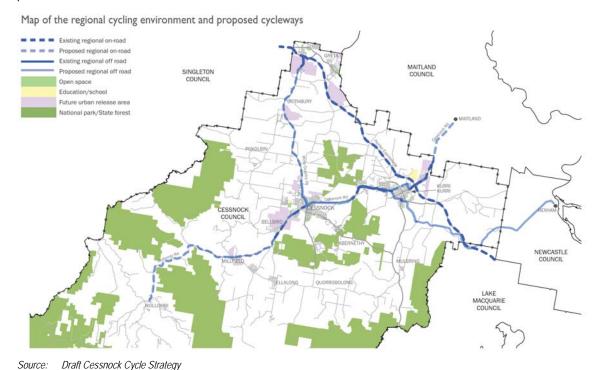
Figure 2.15: Regional Cycle Environment

The regional cycle environment showing the principle cycle network linking villages and adjacent LGAs is illustrated in Figure 2.15. For further details of existing and proposed cycle paths in key centres and villages refer to Council's draft Cycling Strategy (2016).

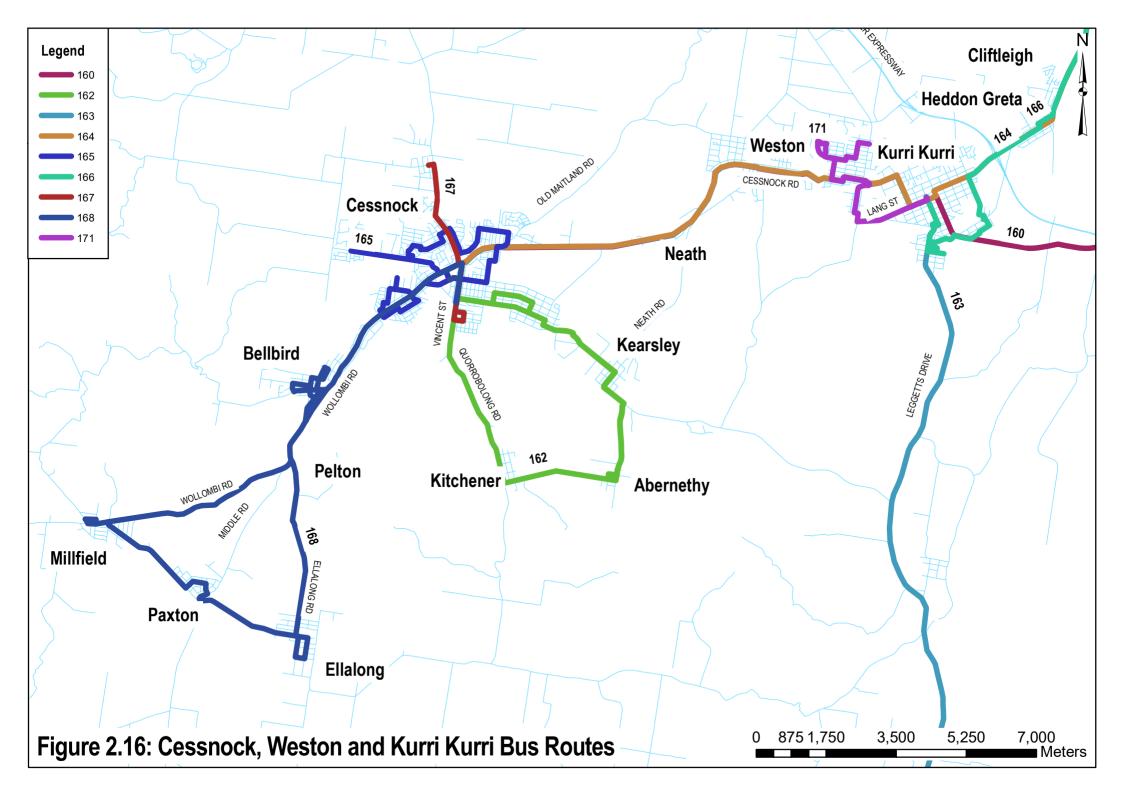
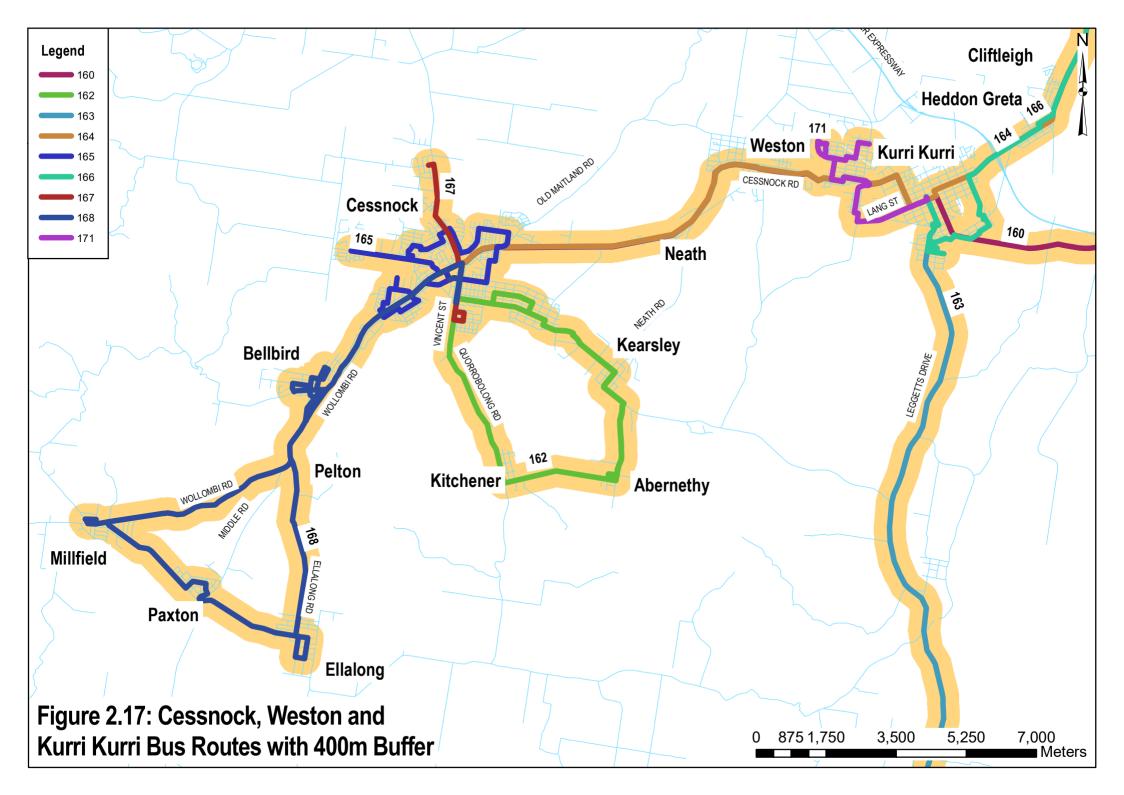
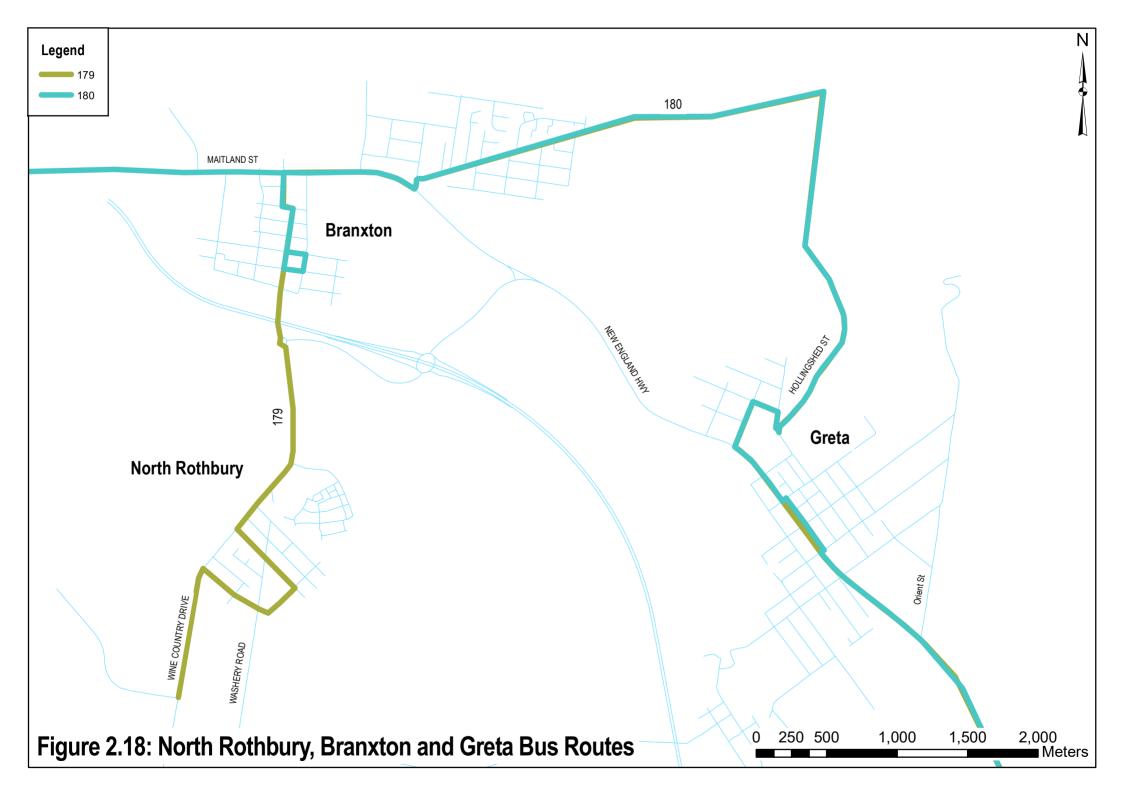
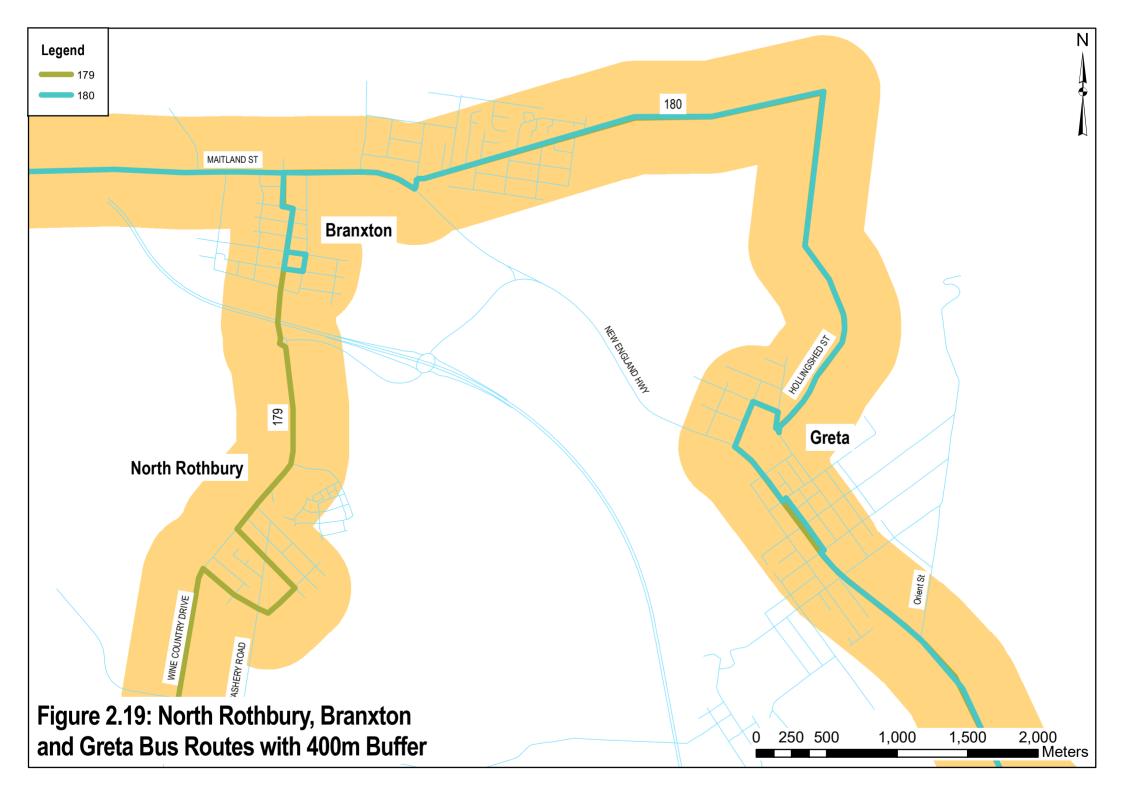
Figures 2.16 and 2.18 illustrate the existing bus routes in Cessnock LGA while Figures 2.17 and 2.19 depict a 400m buffer zone surrounding the existing bus routes. The buffer provides an indication on the level of accessibility for residents to utilise the bus facilities.

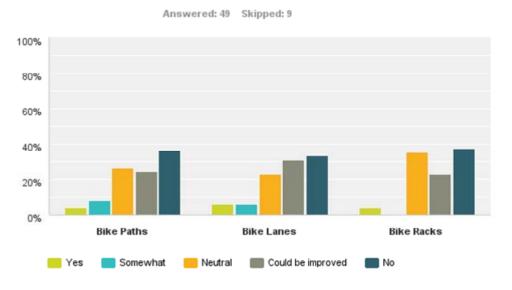
Figure 3.1: Adequacy of Bicycle Facilities

Q22 Are bicycle facilities adequate?

highlighted a lack of on-road, off-road and general recreational bike tracks throughout the majority of Cessnock. The community shows interest in both walking and cycling, however the conditions of footpaths and the absence of connected bike lanes is a deterrent for people who would like to use active transport more frequently. Figures 3.1 and 3.2 illustrate that bicycle and pedestrian facilities are largely regarded as inadequate within the community.

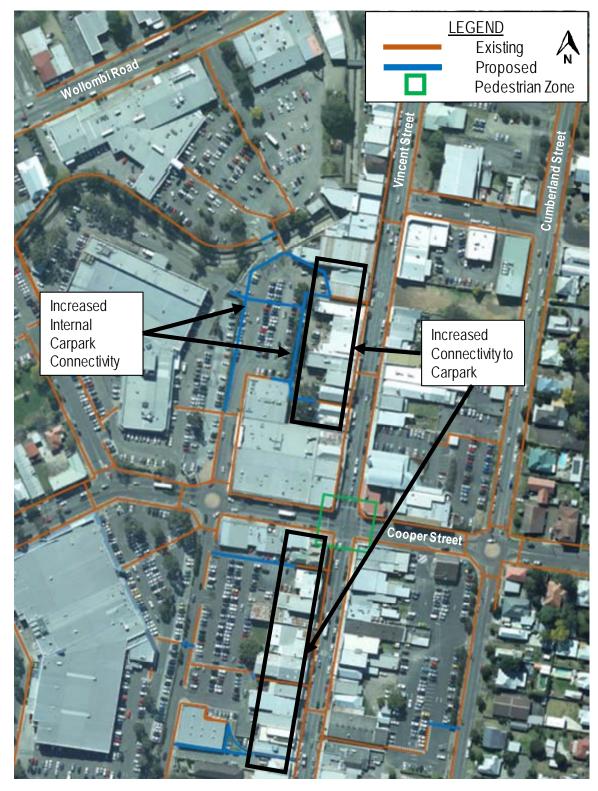
Figure 4.1: Cessnock CBD Routes

Figure 4.1 shows how the side streets and alleyways can be better utilised to increase the permeability in the area. The proposed paths provide links between existing footpaths and aim to increase pedestrian priority and therefore promoting a safe active network. Council will need to work with the private land owners to achieve the desirable pedestrian connectivity illustrated in Figure 4.1. The proposed links are indicative and are subject to change depending on the surrounding land owners.

There are five alleyways along Vincent Street that connect to car parking areas, four of which have existing footpaths but no designated pedestrian paths that connect the carpark area to the alleyways.

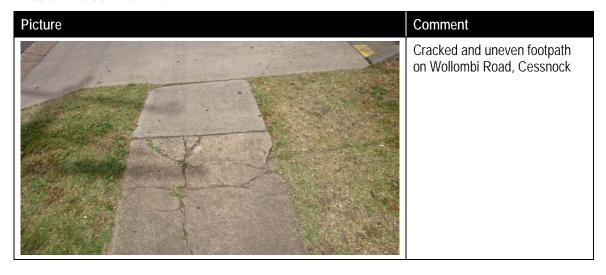
The most common issues associated with footpaths were damaged surfaces due to general wear and tear. In some cases, this created a level difference that made a trip hazard. There were also some missing links to other pedestrian facilities (i.e. bus stops and car parks), a notable example being the bus stop on Mitchell Avenue in Kurri Kurri.

Cracked and uneven footpath on Miller Street, Cessnock

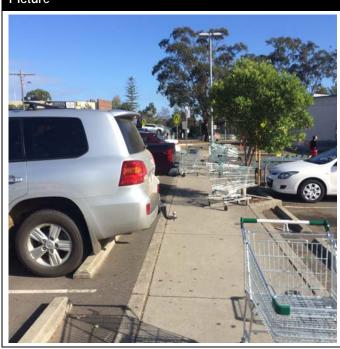
A recurring issue observed was shopping patrons abandoning their trollies on footpaths. This leaves the existing footpaths congested and difficult to manoeuvre especially for people with disabilities.

Shopping carpark path congested with shopping trollies

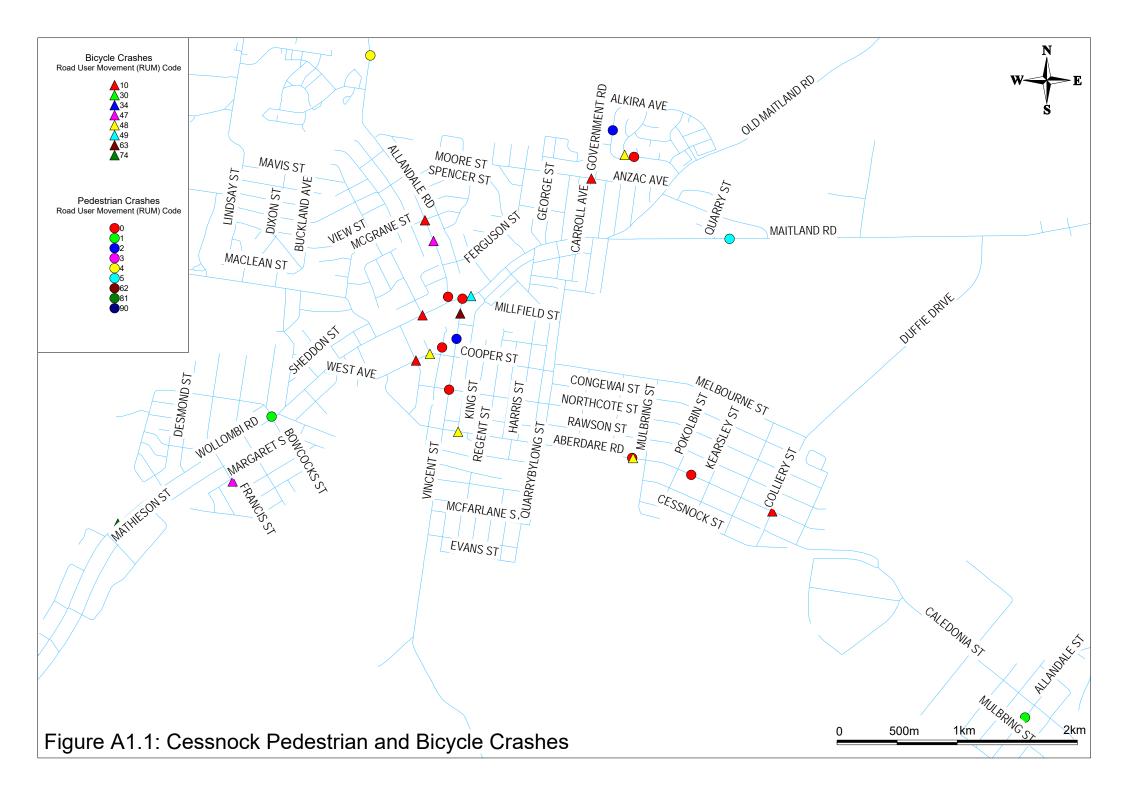
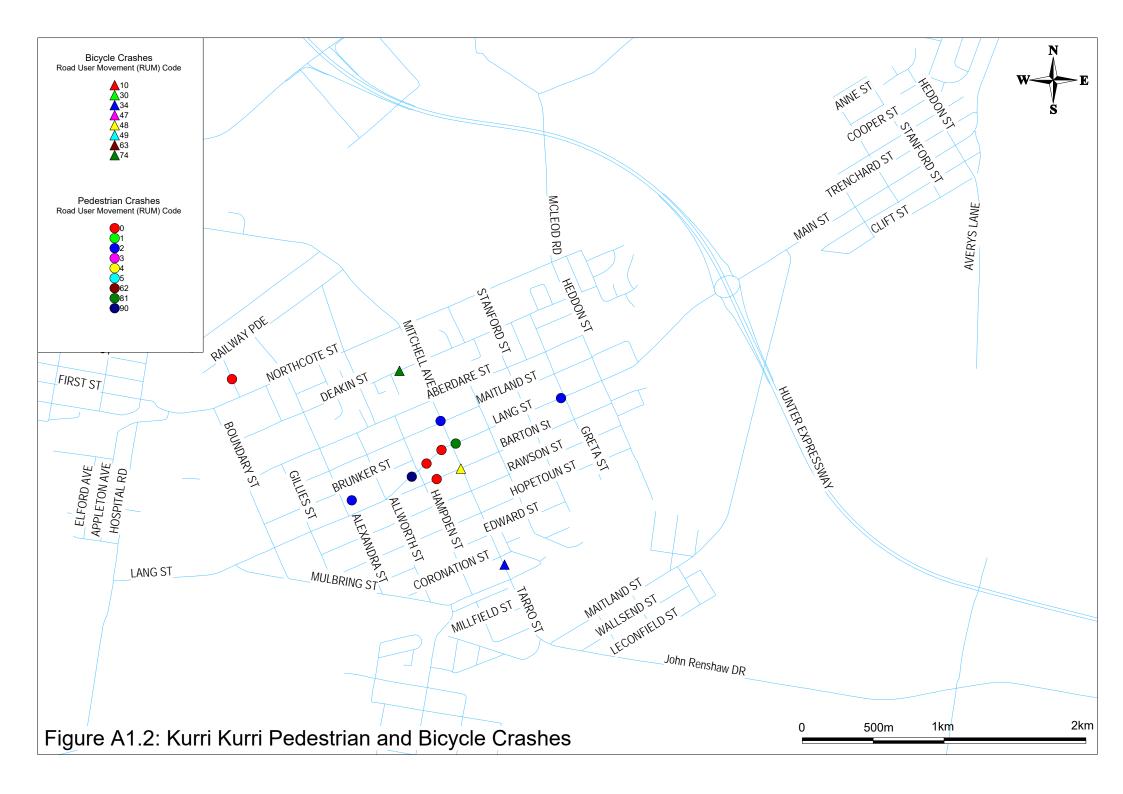
Figures A1.1 and A1.2 show the locations of pedestrians as well as bicycle crashes across Cessnock LGA in Cessnock and Kurri Kurri respectively. The pedestrian and cyclist crashes have generally been clustered around activity centres. Most of the crashes were situated around the Cessnock and Kurri Kurri main streets (Vincent Street and Lang Street). The most common RUM Codes for pedestrian crashes, which describes the first impact of the recorded crash, were found to be 0 and 2 implying that the pedestrian crash most likely occurred as a result of a pedestrian trying to cross the road. For bicycle crashes the most common RUM Codes were 10 and 48 which are cross traffic at intersections and manoeuvring from a footpath respectively.
